**Flood Control Project Maintenance
Levee Inspections****LMA District Cover Sheet****Spring 2014 Levee Inspection Results****Reclamation District No. 0536 Egbert**

Spring 2014 Levee Inspection Results

Reclamation District No. 0536 Egbert

Waterway			Bank	Unit Miles
Unit No. 01 Lindsey Slough			Right	5.66
	Spring (March - May)	Summer (June - August)	(September - November) Fall	Winter (December - February)
Unit Maintenance Rating (Fall Only)				
Date of Inspection	04/09/2014 - 04/09/2014			
DWR Inspector	Herman Phillips			
Accompanied By

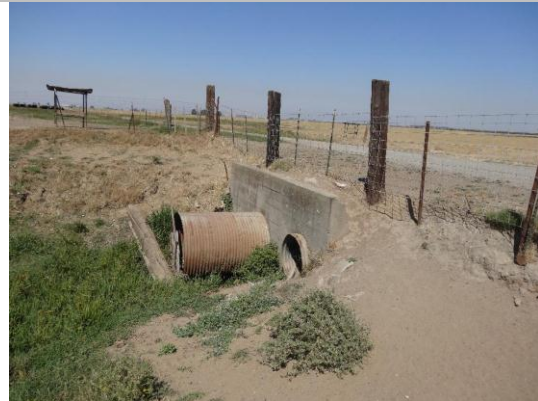
Photo 1 of 1 : UCIP_2234.jpg

LM Start	0.00	Rating **	M	Issue No.	3
LM End	0.00	Issue Type +	En	Location *	LS
Category	Supplemental			GPS Latitude/Longitude	
				Start	End
Item	DWR UCIP Field Study			38.244963 °	38.244963 °
				-121.768960 °	-121.768960 °
DWR ID	DWR_RD0536_01_s _ 2014_3				
Action/Comments					
Inspector Comments: FS_ID:20406					
EP_NO: 10114					
Repair Type:					
Crossing Status:					
UCIP Comments: - Holes in pipe outlet due to heavy corrosion.					
Needs detailed investigation of the pipe.Headwall cracked and tilted on WS.					
FIELD_STRUCT_DESC: 1 of 2: 60-inch corrugated metal pipe (of 60-inch and 36-inch CMP) through levee 10.0 feet below crown in drain ditch. (ABO 10114, 1974). Originally included in the 1953 O&M manual, Sac 106, May 1953.					
FS Date: 8/13/2013

LS view: two inlet CMPs with flap gates. Concrete headwall supports the pipes. A 36" CMP (right) and 60" CMP (left).

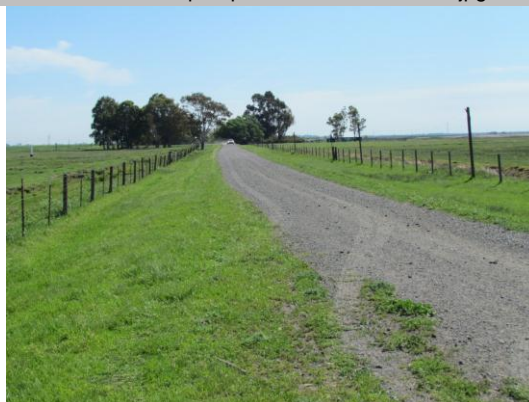
Photo 1 of 1 : phillips_s_20140602_05973.jpg

LM Start	0.02	Rating **	A	Issue No.	21
LM End	0.02	Issue Type +	Ma	Location *	LS
Category	Earthen Levee			GPS Latitude/Longitude	
				Start	End
Item	Vegetation			38.244948 °	38.244948 °
				-121.768637 °	-121.768637 °
DWR ID	DWR_RD0536_01_f_2013_21				
Action/Comments					
Control annual grass and weeds on the levee slopes and easements.

Looking downstream from levee mile 0.02 RD536 Unit 1. Photo taken 09-04-2014.

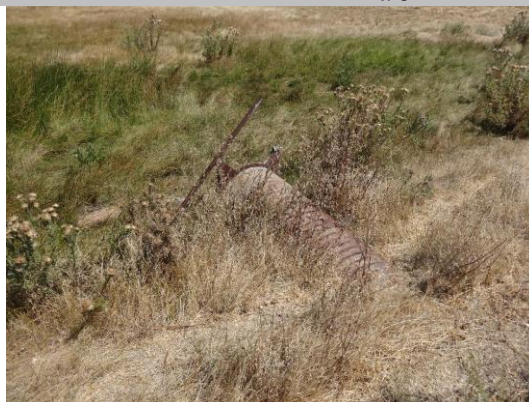
Photo 1 of 1 : UCIP_2272.jpg

LM Start	0.31	Rating **	M	Issue No.	6
LM End	0.31	Issue Type +	En	Location *	WS
Category	Supplemental			GPS Latitude/Longitude	
				Start	End
Item	DWR UCIP Field Study			38.245605 °	38.245605 °
				-121.763441 °	-121.763441 °
DWR ID	DWR_RD0536_01_s_2014_6				
Action/Comments					
Inspector Comments: FS_ID:20675					
EP_NO: 10114					
Repair Type:					
Crossing Status:					
UCIP Comments: Outlet was blocked by concrete debri and					
Needs cleaning of debri.					
FIELD_STRUCT_DESC: 24-inch corrugated metal drain pipe through					
levee 10.5 feet below crown. Flap gate on waterward end. Originally					
included in the 1953 O&M manual, Sac 106, May 1953.					
FS Date: 8/13/2013

WS view: overview of exposed CM pipe on levee slope.

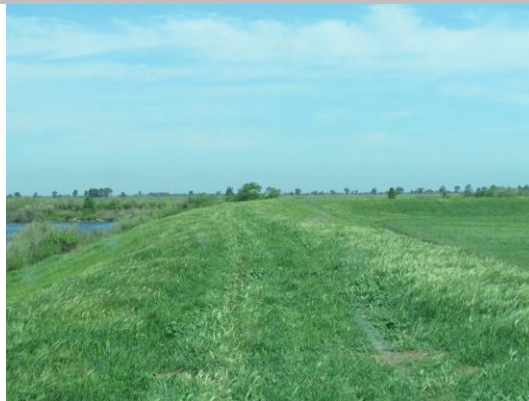
Photo 1 of 1 : phillips_s_20140602_05978.jpg

LM Start	0.70	Rating **	U	Issue No.	28
LM End	2.32	Issue Type +	Ma	Location *	CR
Category	Earthen Levee			GPS Latitude/Longitude	
				Start	End
Item	Vegetation			38.249939 °	38.258615 °
				-121.759730 °	-121.741849 °
DWR ID	DWR_RD0536_01_s _ 2014_28				
Action/Comments					
Keep the crown roadway free of vegetation. Inspector Comments: Grasses taller than 24 inches present on crown roadway.

From levee mile 0.70 -2.32 crown roadway over grown with tall weeds.

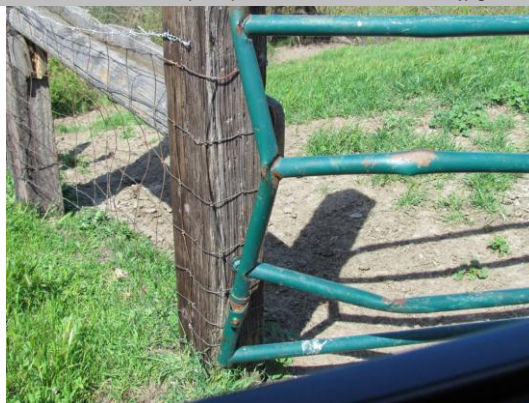
Photo 1 of 1 : phillips_s_20140602_05972.jpg

LM Start	1.10	Rating **	U	Issue No.	25
LM End	1.10	Issue Type +	Ma	Location *	CR
Category	Earthen Levee			GPS Latitude/Longitude	
				Start	End
Item	Repair Gates			38.255455 °	38.255455 °
				-121.757587 °	-121.757587 °
DWR ID	DWR_RD0536_01_s _ 2014_25				
Action/Comments					
Inspector Comments: This gate looks like its been run over, the bottom hinge is broken thus making the gate hard to open and close properly.

This gate needs to be replaced.

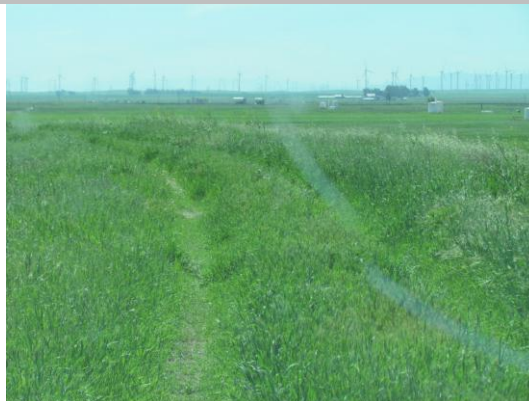
Photo 1 of 1 : phillips_s_20140602_05974.jpg

LM Start	1.76	Rating **	U	Issue No.	51
LM End	1.84	Issue Type +	Ma	Location *	CR
Category	Earthen Levee			GPS Latitude/Longitude	
				Start	End
Item	Vegetation			38.259686 °	38.259986 °
				-121.749950 °	-121.748717 °
DWR ID	DWR_RD0536_01_f_2013_51				
Action/Comments					
Remove the wild growth other than native grasses from the levee slopes.					
Inspector Comments: Growth on crown roadway taller than 12 inches.

RD 536 Looking downstream from levee mile 1.76-1.84 crown overgrown with weeds. Photo taken 09-04-2014.

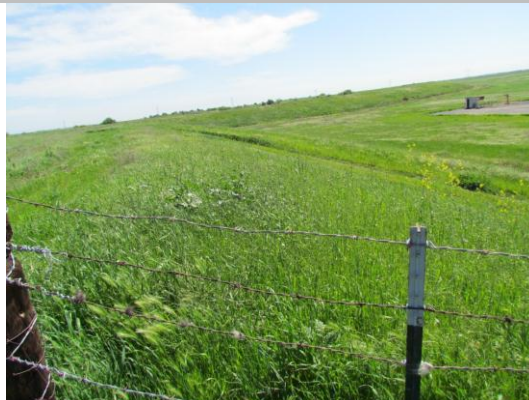
Photo 1 of 1 : phillips_s_20140602_05975.jpg

LM Start	1.76	Rating **	U	Issue No.	41
LM End	4.91	Issue Type +	Ma	Location *	LS
Category	Earthen Levee			GPS Latitude/Longitude	
				Start	End
Item	Vegetation			38.259687 °	38.245426 °
				-121.749982 °	-121.709133 °
DWR ID	DWR_RD0536_01_s_2014_41				
Action/Comments					
Control annual grass and weeds on the levee slopes and easements.					
Inspector Comments: Weed/grasses taller than 24 inches present on levee slope and shoulder.

Tall weeds has taken over the landside slope.

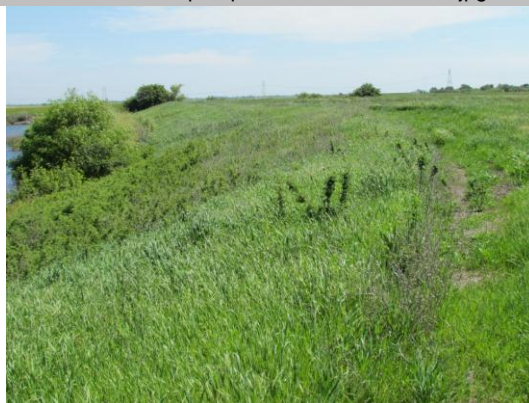
Photo 1 of 1 : phillips_s_20140602_05976.jpg

LM Start	1.76	Rating **	U	Issue No.	37
LM End	4.68	Issue Type +	Ma	Location *	WS
Category	Earthen Levee			GPS Latitude/Longitude	
				Start	End
Item	Vegetation			38.259698 °	38.247721 °
				-121.750004 °	-121.711768 °
DWR ID	DWR_RD0536_01_s _ 2014_37				
Action/Comments					
Control annual grass and weeds on the levee slopes and easements. Inspector Comments: Growth taller than 24 inches present on levee section.

Looking downstream at the waterside slope and toe over taken with tall weeds.

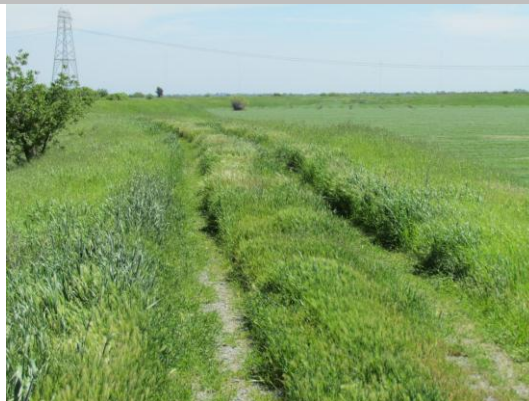
Photo 1 of 1 : phillips_s_20140602_05977.jpg

LM Start	2.54	Rating **	U	Issue No.	61
LM End	4.68	Issue Type +	Ma	Location *	CR
Category	Earthen Levee			GPS Latitude/Longitude	
				Start	End
Item	Vegetation			38.257269 °	38.247720 °
				-121.738446 °	-121.711769 °
DWR ID	DWR_RD0536_01_s _ 2014_61				
Action/Comments					
Keep the crown roadway free of vegetation.

Looking downstream from levee mile to 4.68 at crown roadway overgrown with tall weeds.

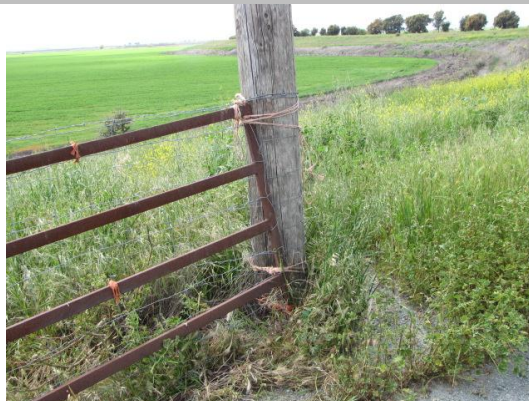
Photo 1 of 1 : phillips_s_20140306_912.jpg

LM Start	3.68	Rating **	U	Issue No.	36
LM End	3.68	Issue Type +	Ma	Location *	WS
Category	Earthen Levee			GPS Latitude/Longitude	
				Start	End
Item	Repair Gates			38.252578 °	38.252578 °
				-121.726439 °	-121.726439 °
DWR ID	DWR_RD0536_01_s _ 2012_36				
Action/Comments					
Inspector Comments: This gate need to be repaired.

Repair this gate. Someone could get hurt trying to open and close this gate. No new picture was taken, no change to this gate. 09-04-2014.

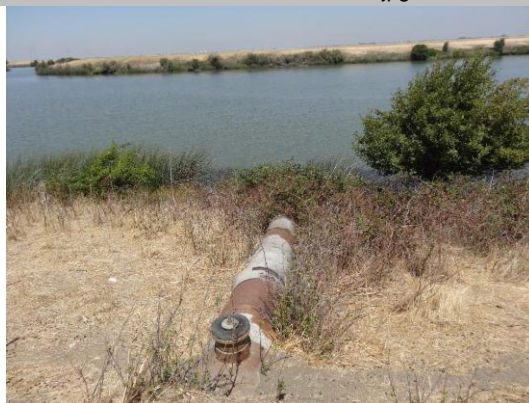
Photo 1 of 1 : UCIP_2242.jpg

LM Start	3.95	Rating **	M	Issue No.	9
LM End	3.95	Issue Type +	En	Location *	WS
Category	Supplemental			GPS Latitude/Longitude	
				Start	End
Item	DWR UCIP Field Study			38.250693 °	38.250693 °
				-121.722759 °	-121.722759 °
DWR ID	DWR_RD0536_01_s _ 2014_9				
Action/Comments					
Inspector Comments: FS_ID:20504					
EP_NO: 2131					
Repair Type:					
Crossing Status:					
UCIP Comments: Pump is missing at the time of inspection. May be taken out for repair. Flap gate on waterward end not found/visible as pipe was submerged into water. Pipe itself is a walkway with steel handrail.					
FIELD_STRUCT_DESC: 20-inch pipe through levee 1.5 feet below crown. Pump on steel platform in drain ditch on landward side. Siphon breaker on waterward slope exposed on both slopes. (Permit No. 2131, 1955).					
FS Date: 8/13/2013

WS view: exposed steel pipe with siphon breaker on levee slope.

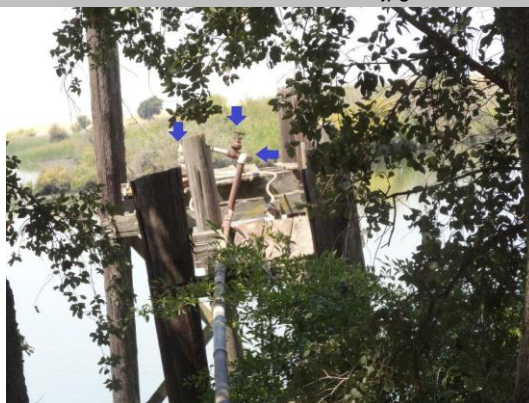
Photo 1 of 1 : UCIP_2247.jpg

LM Start	4.97	Rating **	M	Issue No.	10
LM End	4.97	Issue Type +	En	Location *	WS
Category	Supplemental			GPS Latitude/Longitude	
				Start	End
Item	DWR UCIP Field Study			38.245643 °	38.245643 °
				-121.708162 °	-121.708162 °
DWR ID	DWR_RD0536_01_s_2014_10				
Action/Comments					
Inspector Comments: FS_ID:20523					
EP_NO: 10116					
Repair Type:					
Crossing Status:					
UCIP Comments: Pipe seems to be abandoned. Catwalk and pumphouse on riverside not found. It is not clear whether the pipe pass through the levee or not. Needs more info from LMA/DWR Inspector.					
FIELD_STRUCT_DESC: 3-inch B.I. galvanized pipe through levee 4.0 feet below crown. Concrete cradle and tank on waterward slope.					
FS Date: 8/13/2013

WS view: pump, pipe, gate valve, and wooden piling structure in the stream.

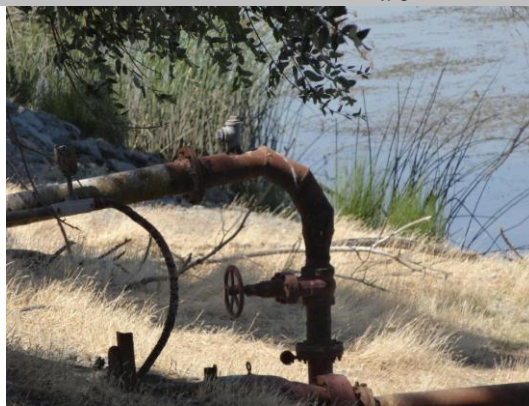
Photo 1 of 1 : UCIP_2249.jpg

LM Start	5.10	Rating **	M	Issue No.	12
LM End	5.10	Issue Type +	En	Location *	WS
Category	Supplemental			GPS Latitude/Longitude	
				Start	End
Item	DWR UCIP Field Study			38.245783 °	38.245783 °
				-121.705999 °	-121.705999 °
DWR ID	DWR_RD0536_01_s_2014_12				
Action/Comments					
Inspector Comments: FS_ID:20543					
EP_NO: 3873					
Repair Type:					
Crossing Status:					
UCIP Comments: Pipe seems to be abandoned. Needs proper abandonment.					
FIELD_STRUCT_DESC: 6-inch pipe through levee 2. 0 feet below crown. Pump on concrete base on waterward slope. Gate valve on waterward slope. (Permit No.3873, 1962).					
FS Date: 8/13/2013

WS view: abandoned pipe, pump, conduit, and gate valve on levee slope.

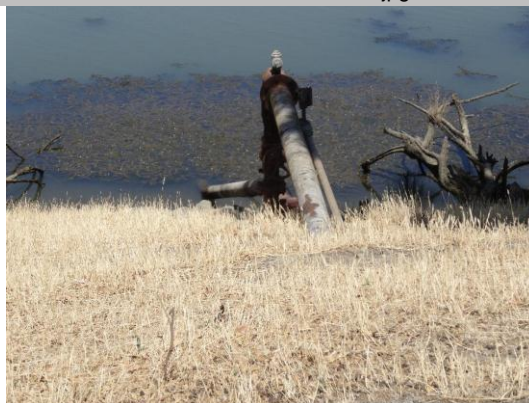
Photo 1 of 1 : UCIP_2352.jpg

LM Start	5.10	Rating **	M	Issue No.	13
LM End	5.10	Issue Type +	En	Location *	WS
Category	Supplemental			GPS Latitude/Longitude	
				Start	End
Item	DWR UCIP Field Study			38.245783 °	38.245783 °
				-121.705999 °	-121.705999 °
DWR ID	DWR_RD0536_01_s_2014_13				
Action/Comments					
Inspector Comments: FS_ID:20869					
EP_NO: N/A					
Repair Type:					
Crossing Status:					
UCIP Comments: Field discovered pipe crossing. Needs more information from LMA/DWR Inspector. Also needs more detailed inspection.					
FIELD_STRUCT_DESC: Approximately 6-inch steel pipe and an electric conduit through levee. A slant pump in steel support on channel bank. Gate valve on the pipe. No pipes and appurtenances on landside. Field discovered pipe crossing.					
FS Date: 8/13/2013

WS view: closer view of pipe and pump on channel bank.

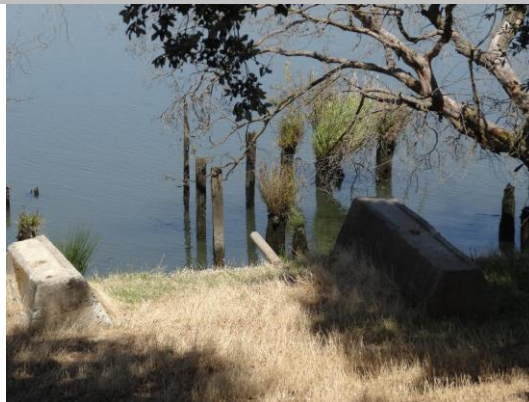
Photo 1 of 1 : UCIP_2250.jpg

LM Start	5.12	Rating **	M	Issue No.	17
LM End	5.12	Issue Type +	En	Location *	WS
Category	Supplemental			GPS Latitude/Longitude	
				Start	End
Item	DWR UCIP Field Study			38.245588 °	38.245588 °
				-121.705723 °	-121.705723 °
DWR ID	DWR_RD0536_01_s_2014_17				
Action/Comments					
Inspector Comments: FS_ID:20544					
EP_NO: N/A					
Repair Type:					
Crossing Status:					
UCIP Comments: - field discovered pipe seems abandoned pipe.					
Needs proper abandonment.					
FIELD_STRUCT_DESC: An abandoned 6-inch galvanized iron pipe on top of concrete pad and through levee. Details not available.					
FS Date: 8/13/2013

WS view: abandoned steel pipe on concrete pad.

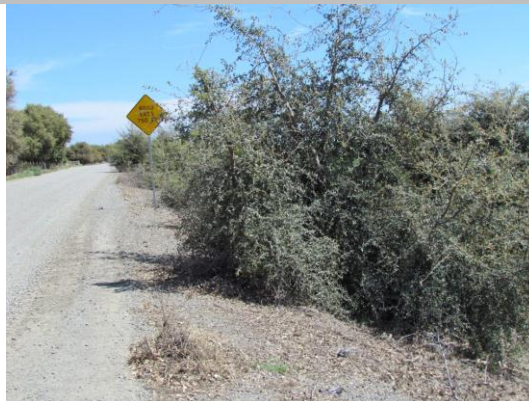
Photo 1 of 1 : phillips_s_20140602_05979.jpg

Looking downstream from levee mile 5.17 to 5.31 at unsatisfactory woody tree growth on landside levee slope and shoulder.

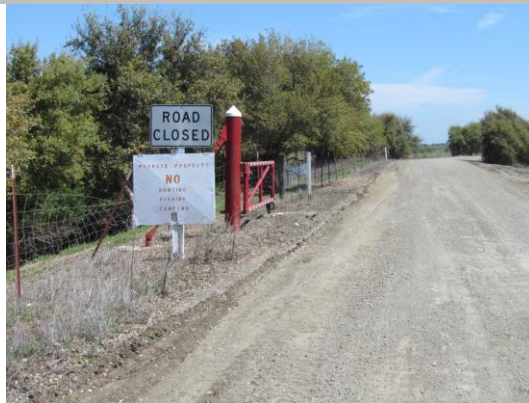
Photo 1 of 1 : phillips_s_20140602_05980.jpg

This gate and barricade has no CVFPB permit on file.

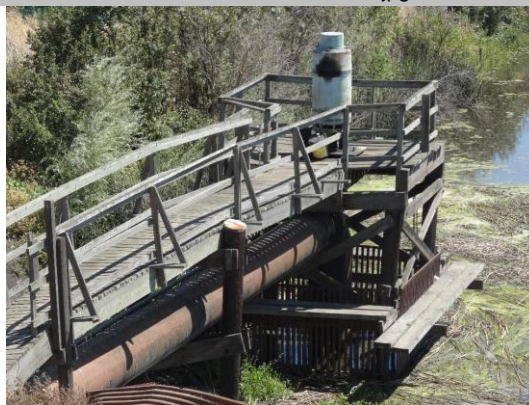
Photo 1 of 1 : UCIP_2252.jpg

LM Start	5.50	Rating **	M	Issue No.	19
LM End	5.50	Issue Type +	En	Location *	LS
Category	Supplemental			GPS Latitude/Longitude	
				Start	End
Item	DWR UCIP Field Study			38.245512 °	38.245512 °
				-121.699119 °	-121.699119 °
DWR ID	DWR_RD0536_01_s_2014_19				
Action/Comments					
Inspector Comments: FS_ID:20563					
EP_NO: 7208					
Repair Type:					
Crossing Status:					
UCIP Comments: - siphon breaker needs cover/protection.service pole on landside of the levee.					
FIELD_STRUCT_DESC: 30-inch steel drain pipe through levee 5.7 feet below crown. Pump in piling structure in drain ditch on landward side.					
Siphon breaker on waterward shoulder. (Permit No. 7208, 1971)					
FS Date: 8/13/2013

LS view: pipe under the wooden walkway and pump on wooden platform in drain ditch.

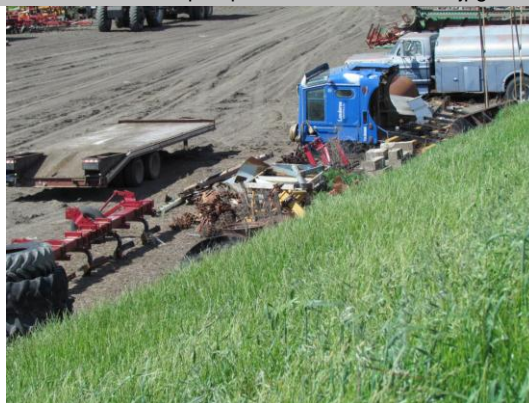
Photo 1 of 1 : phillips_s_20140602_05984.jpg

Unauthorized encroachment on the landward side within 10-foot of the levee toe, looking back upstream.

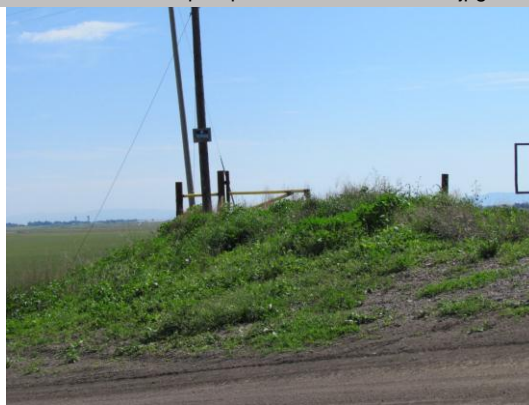
Photo 1 of 1 : phillips_s_20140602_05981.jpg

LM Start	0.01	Rating **	U	Issue No.	15
LM End	0.77	Issue Type +	Ma	Location *	WS
Category	Earthen Levee			GPS Latitude/Longitude	
				Start	End
Item	Vegetation			38.244295 °	38.233468 °
				-121.697016 °	-121.697968 °
DWR ID	DWR_RD0536_02_s _ 2014_15				
Action/Comments					
Control annual grass and weeds on the levee slopes and easements. Inspector Comments: Weeds 3-foot tall present on slope and shoulder.

Looking downstream at waterside slope and shoulder covered with wild weed growth.

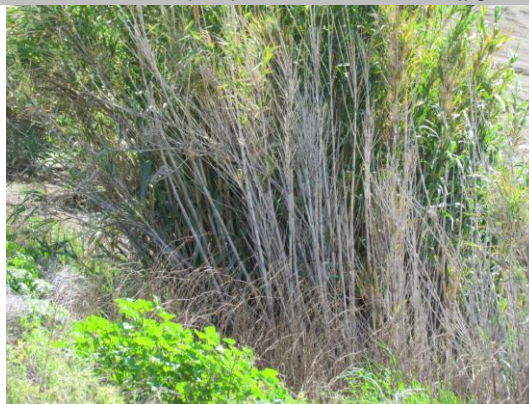
Photo 1 of 1 : phillips_s_20140602_05985.jpg

LM Start	0.02	Rating **	U	Issue No.	17
LM End	0.02	Issue Type +	Ma	Location *	LS
Category	Earthen Levee			GPS Latitude/Longitude	
				Start	End
Item	Vegetation			38.244225 °	38.244225 °
				-121.696980 °	-121.696980 °
DWR ID	DWR_RD0536_02_s _ 2014_17				
Action/Comments					
Remove the wild growth other than native grasses from the levee slopes.					
Inspector Comments: Bambo on landside toe.

Remove unwanted growth of bambo from landward toe.

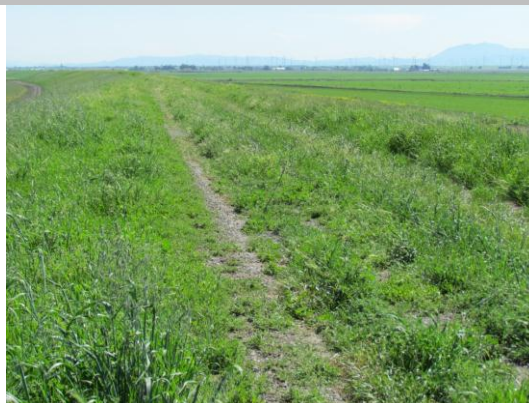
Photo 1 of 1 : phillips_s_20140602_05982.jpg

Crown roadway covered with tall weeds.

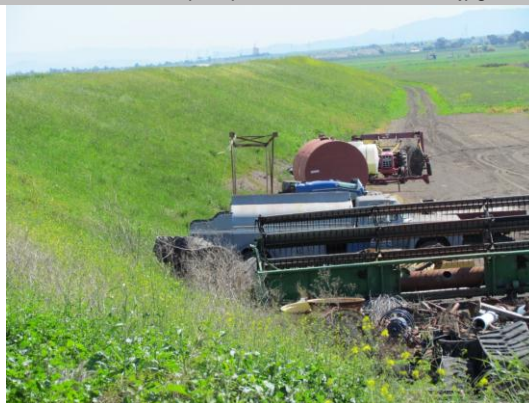
Photo 1 of 1 : phillips_s_20140602_05983.jpg

LM Start	0.10	Rating **	U	Issue No.	19
LM End	0.10	Issue Type +	En	Location *	LS
Category	Earthen Levee			GPS Latitude/Longitude	
				Start	End
Item	Encroachments			38.243168 °	38.243168 °
				-121.697040 °	-121.697040 °
DWR ID	DWR_RD0536_02_s_2014_19				
Action/Comments					
Equipment

Unauthorized encroachment on landside toe, farm equipment and fuel tanks within 10-foot of the landside toe.

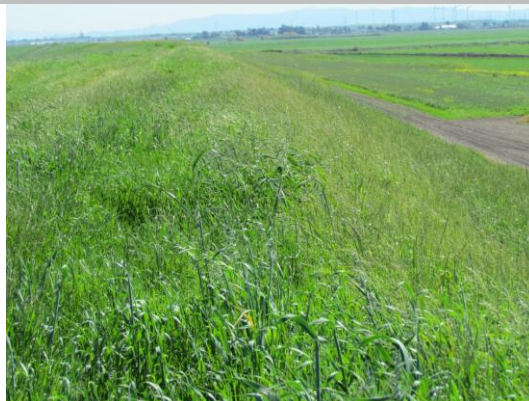
Photo 1 of 1 : phillips_s_20140602_05986.jpg

Looking downstream from levee mile 0.26 landside slope to levee mile 3.40 tall weeds covering levee section.

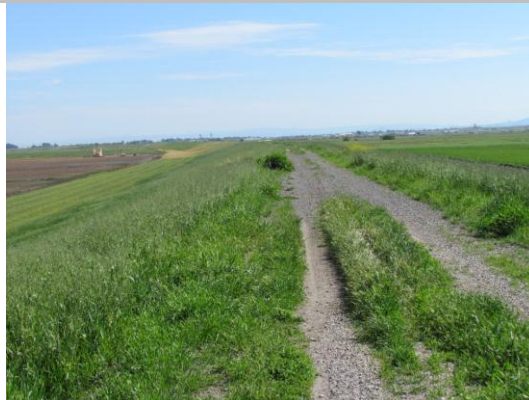
Photo 1 of 1 : phillips_s_20140602_05987.jpg

Looking downstream from levee mile 0.77 to levee mile 3.40 waterside slope overgrown with tall weeds.

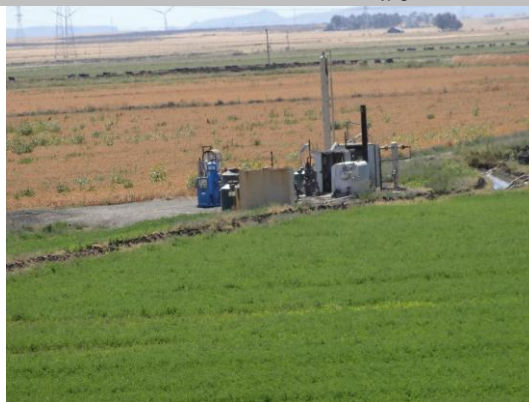
Photo 1 of 1 : UCIP_2258.jpg

LM Start	1.40	Rating **	M	Issue No.	4
LM End	1.40	Issue Type +	En	Location *	CR
Category	Supplemental			GPS Latitude/Longitude	
				Start	End
Item	DWR UCIP Field Study			38.224423 °	38.224423 °
				-121.697049 °	-121.697049 °
DWR ID	DWR_RD0536_02_s _ 2014_4				
Action/Comments					
Inspector Comments: FS_ID:20664					
EP_NO: 17829					
Repair Type:					
Crossing Status:					
UCIP Comments: Indicator is found only on WS. The indicator is different than standard indicator. Needs more info from LMA/DWR Inspector.					
FIELD_STRUCT_DESC: 3.5-inch welded steel natural gas pipe through levee 44.0 feet below crown (Permit No. 17829, 2004).					
FS Date: 8/13/2013

WS view: natural gas extraction plant near levee on the field.

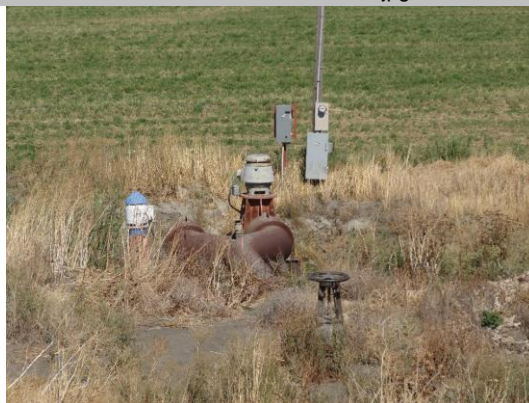
Photo 1 of 1 : UCIP_2257.jpg

LM Start	2.44	Rating **	M	Issue No.	8
LM End	2.44	Issue Type +	En	Location *	CR
Category	Supplemental			GPS Latitude/Longitude	
				Start	End
Item	DWR UCIP Field Study			38.210063 °	38.210063 °
				-121.691768 °	-121.691768 °
DWR ID	DWR_RD0536_02_s_2014_8				
Action/Comments					
Inspector Comments: FS_ID:20647					
EP_NO: N/A					
Repair Type:					
Crossing Status:					
UCIP Comments: Needs more info from LMA/DWR Inspector. Pump and pipe looks new.					
FIELD_STRUCT_DESC: A 12-inch steel pipe with vertical pump on drainage ditch. No other details available.					
FS Date: 8/13/2013

WS view: overview of pipe and pump (left). Big pump and appurtenances (right) for 24" steel pipe.

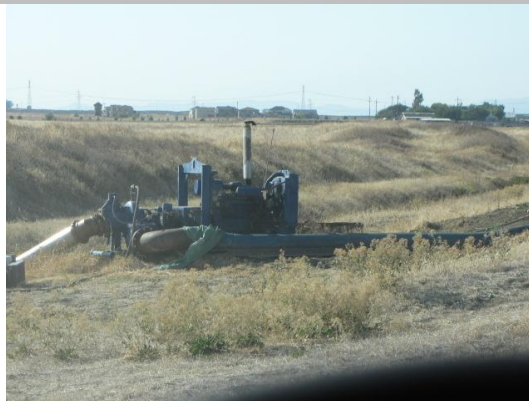
Photo 1 of 1 : phillips_s_20140306_919.JPG

Diesel motor and temporary pipe crossing levee. Photo taken 10-10-2013.

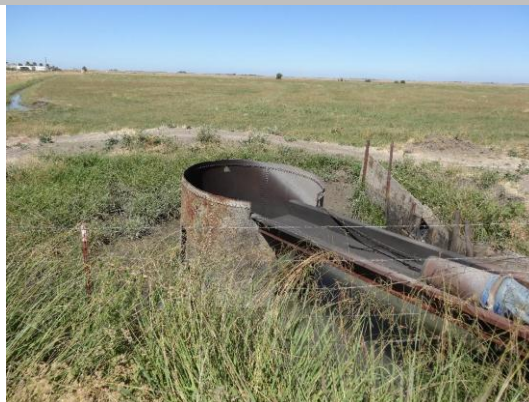
Photo 1 of 1 : UCIP_2265.jpg

LM Start	4.31	Rating **	M	Issue No.	11
LM End	4.31	Issue Type +	En	Location *	CR
Category	Supplemental			GPS Latitude/Longitude	
				Start	End
Item	DWR UCIP Field Study			38.196429 °	38.196429 °
				-121.698962 °	-121.698962 °
DWR ID	DWR_RD0536_02_s _ 2014_11				
Action/Comments					
Inspector Comments: FS_ID:20673					
EP_NO: N/A					
Repair Type:					
Crossing Status:					
UCIP Comments: Canvase pipe is also used. Both sides have standpipe. Needs more exploration about the crossing.					
FIELD_STRUCT_DESC: 18-inch steel pipe on waterside of the levee. Steel standpipe on both sides of the levee. Temporary canvas about 2" below crown. Needs more exploration.					
FS Date: 8/13/2013

LS view: steel standpipe on levee slope.
